Industrial Property – Northern NJ

Client Type/Property Type: International Consultant – Industrial Property

Contaminant: Chlorinated Solvents

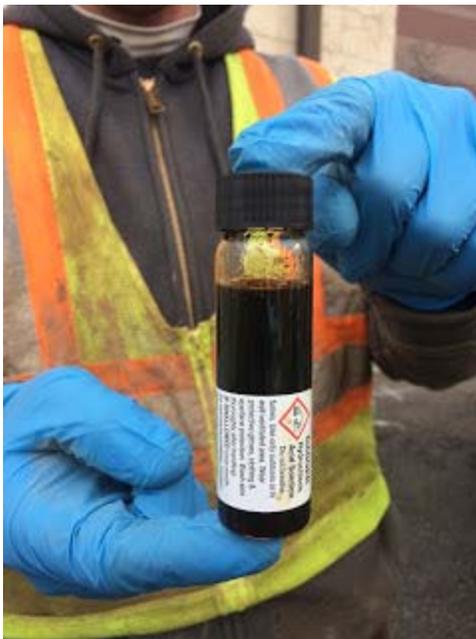
concentrations of dissolved phase CVOCs, but no source material. Early on the third day of the investigation, on boring number 17, the find was made. It was immediately clear from the MIP detector response that very high concentrations were present and DNAPL was likely. A logical question to be asked when using the MIP and encountering DNAPL is, “Can the MIP system “recover” when encountering DNAPL?” Yes, it can, if you are prepared, using the right equipment and your operator is alert. It should be noted that we were running our system/detectors in S2C2’s standard operating mode. While the source material certainly caused an elevated baseline, the field team was able to resume working within a reasonable time frame. The XSD (our chlorinated specific detector) baseline was usable within the hour (approximately 30 minutes longer than it normally takes to remove the tool-string, seal the borehole, decon and perform a response test and setup on the next location).

Due to the elevated baseline and stopping the log “short”, due to encountering such a high response, the MIP was unable to clearly identify a 'bottom' of the impacts. This was easily rectified by very simply collecting a discrete macro core sample through the impacted zone. The core from that interval clearly showed a free phase DNAPL on top of a thick clay, with concentration dropping off dramatically deeper in the clay. The photo of the DNAPL was from a temporary groundwater sample point, collected using [Geoprobe’s SP22 groundwater sampling system](#), right above the clay. Note the pump was shutoff after just a few seconds when only DNAPL (no water) was produced. Confirmation soil and groundwater samples were collected and upon obtaining results an initial 3D visualization will be completed. Further “source” area delineation work will be conducted in the future.
